## INVESTIGATING CAUSES OF FLEXIBLE PAVEMENT FAILURE: A CASE STUDY OF THE BAKO TO NEKEMTE ROAD, OROMIA, ETHIOPIA

**Abstract** — Most of the roads constructed in Ethiopia fail prematurely before serving the design life due to various causes arising from many factors. One of the roads that failed before reaching its design lifetime is the Bako to Nekemte Trunk Road. This road was constructed and opened to traffic in 2013. The design pavement life was estimated at 20 years. However; pavement failures have manifested since 2014 after it was opened for traffic. The main objective of this research was to investigate the cause for the failure of flexible pavement on the Bako to Nekemte road segment. To achieve this objective, the study was followed by the experimental research type and purposive sampling method. Also, field observation and pavement condition survey methods for data collection were used. The asphalt, base course, subgrade, and sub-base layer material sampled from the road segment are the material used for this study. Different pavement failures such as rutting, pothole, alligator cracking, raveling, edge cracking, depression, and corrugation were observed along the road s

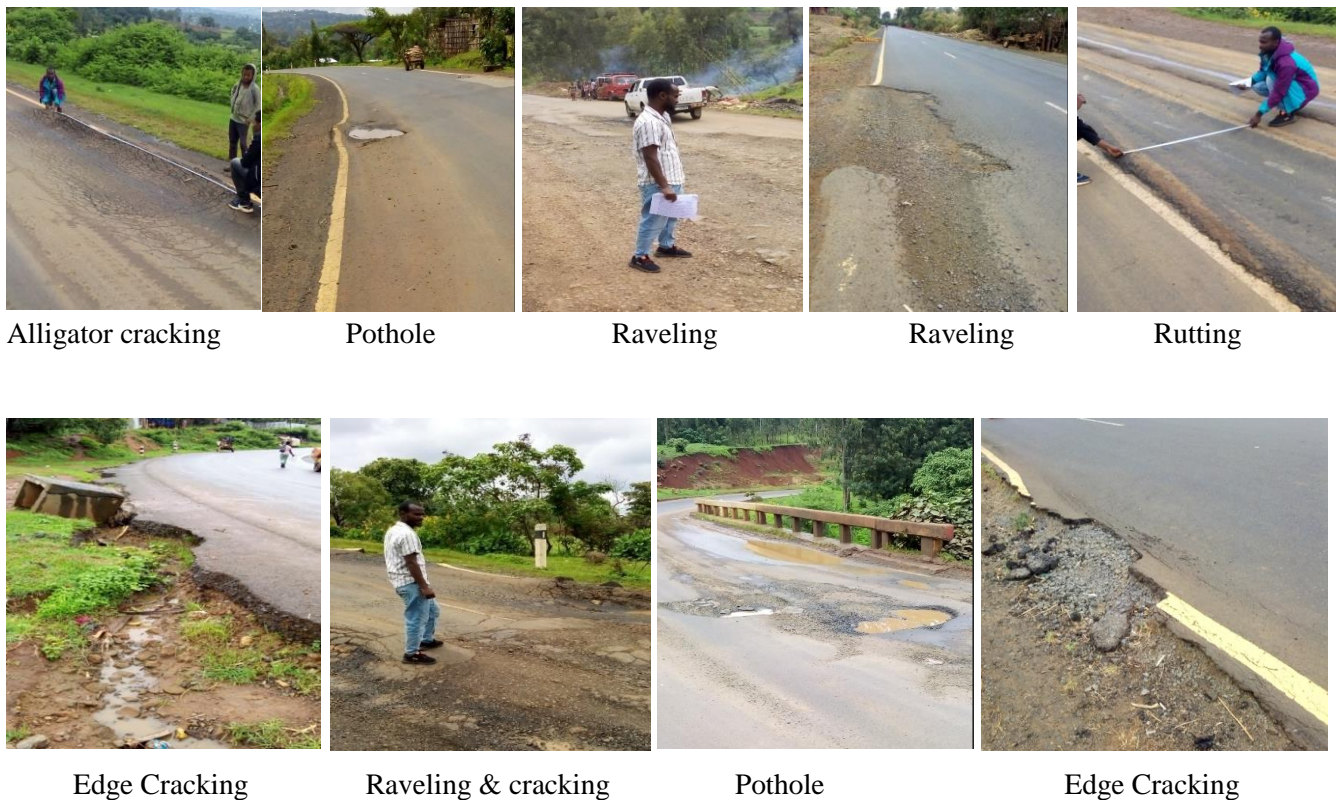
**Figure 2** Pavement failure types were observed along the road segment.

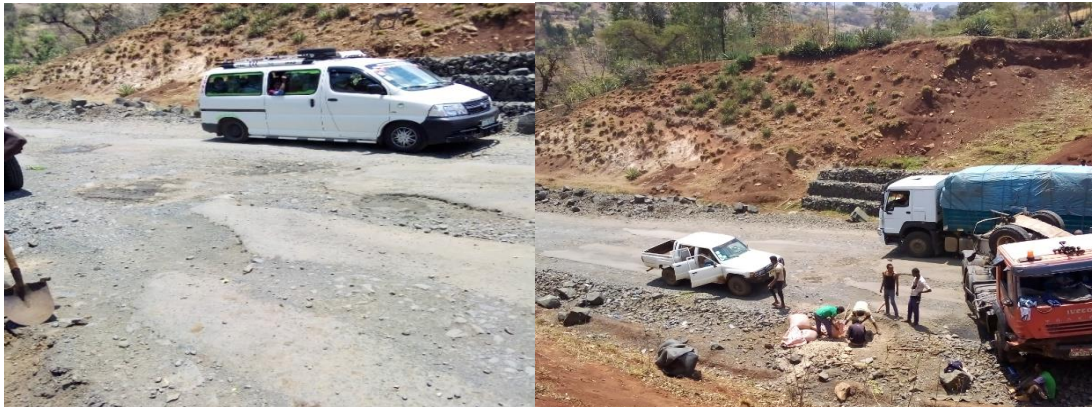
**Figure 3** Sample was taken at 38+900-39+000

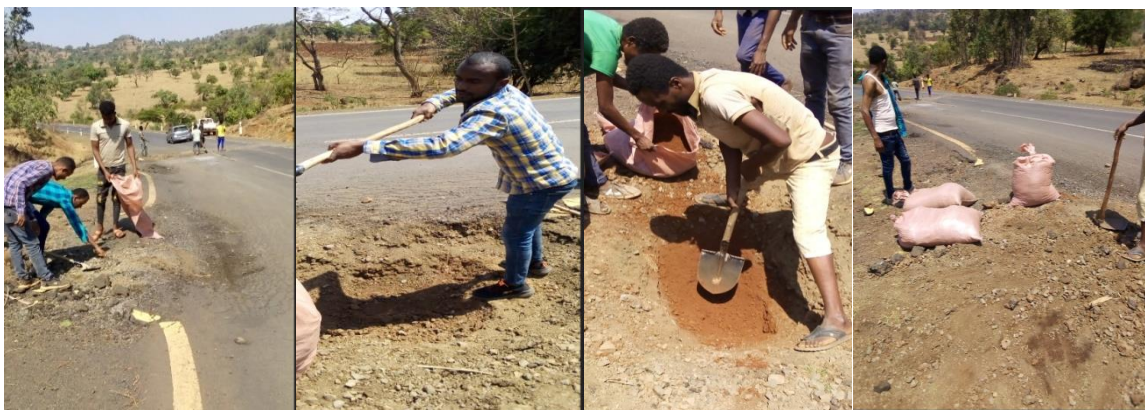
**Figure 4** Sample was taken at 18+300-18+400

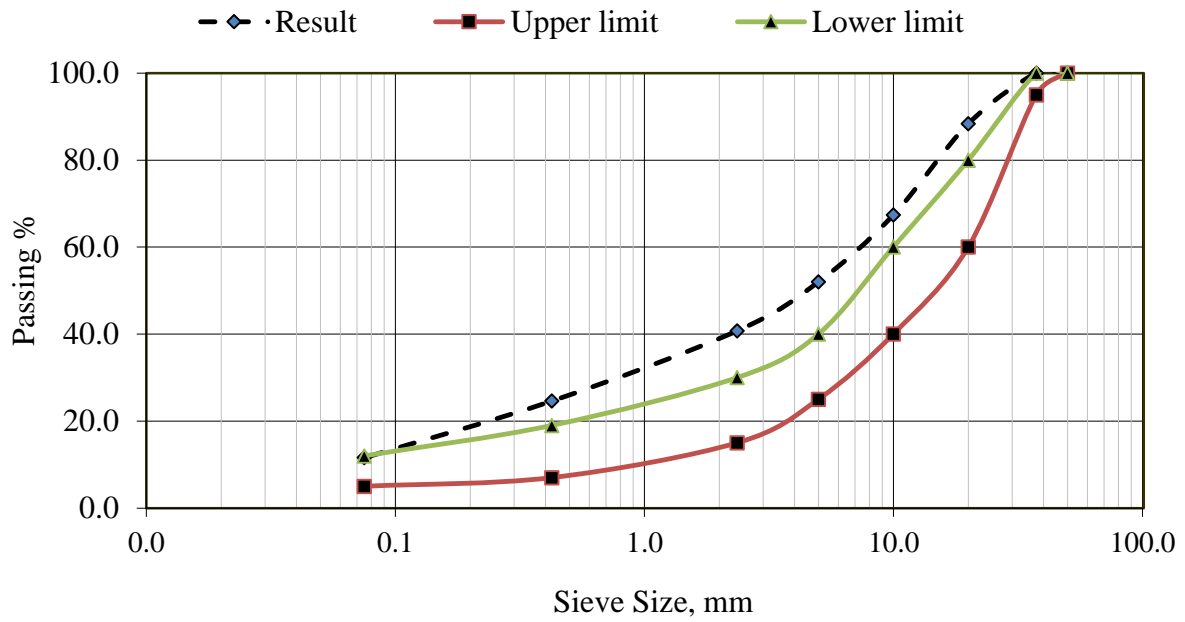
This test was performed to determine the percentage of different grain sizes contained within the Base course materials. Figure 5 and 6 show the sieve analysis test results of Base Course Materials. From 38+900-39+000 stations (failed pavement), the gradation results are completely out of the ERA specification range. This indicates that the base course at this station was poorly graded. Also, from 18+300-18+400 station (poor pavement condition), the gradation results are partially in the range of ERA specification. This implies that the base course at this station was poorly graded. Similarly, from 9+200-9+300 station (poor pavement condition) the gradation results of base course material are fully into the range of ERA specification and consequently, the materials were well graded. The base course material shall be of such nature that can be compacted readily to form a firm, stable base layer. And also a placed layer must have a mass mechanical interlocking stability sufficient to resist loads imposed during the design life of a pavement. Well-graded base course materials are dense and more compact than poorly graded. As a result; they are more resistant to rutting, alligator cracking, and pothole. Therefore, from 38+900-39+000 station (failed pavement), poorly graded base course can be a cause for the occurrence of Pothole and raveling. Similarly, rutting, pothole, and alligator cracking observed from 18+300-18+400 station (poor pavement condition) was also due to base course gradation.

**Figure 5** Gradation of existing base course material from 38+900-39+000

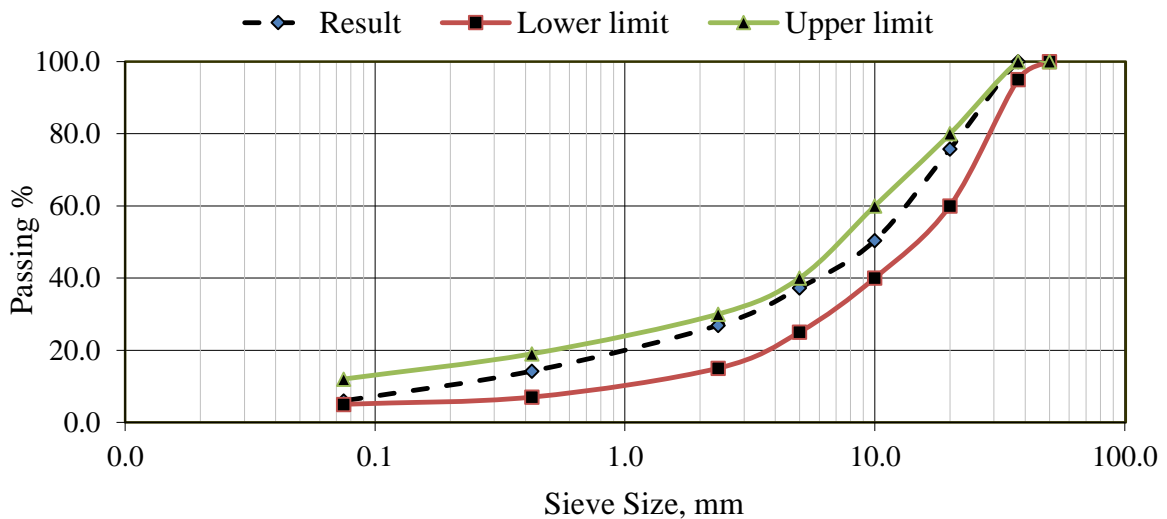
**Figure 6** Gradation of existing base course material from 9+200-9+300

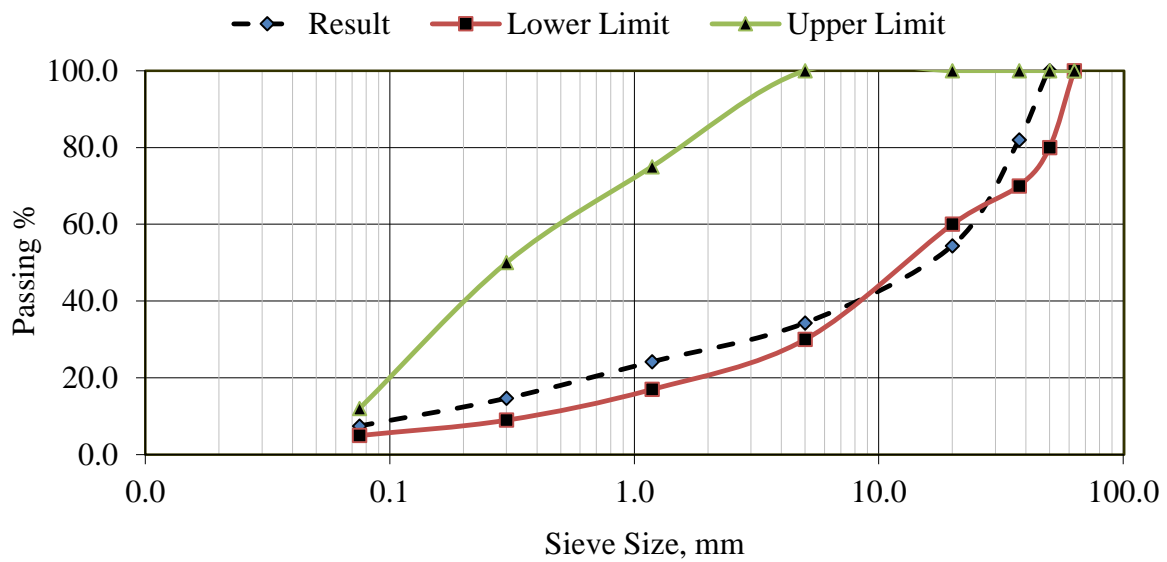
In the whole stretch of the road, the brown granular material was used as a sub-base material. For all samples tested gradation results are within the minimum and maximum range limit of the ERA specification except sample at station (9+200-9+300). The gradation result of sub-base material from the 9+200-9+300 station indicated that the pavement is poor which may be due to the material was not dense and durable. For this reason, they were not able to resist traffic loads and rutting occurred. Therefore, poorly graded sub-base materials can be responsible for the manifestation of rutting on the road sections. Figure 7 and 8 show the grain size analysis result and comparison of sample sub-base material gradation with the ERA manual specification.

**Figure 7** Gradation of existing sub-base material from 9+200-9+300

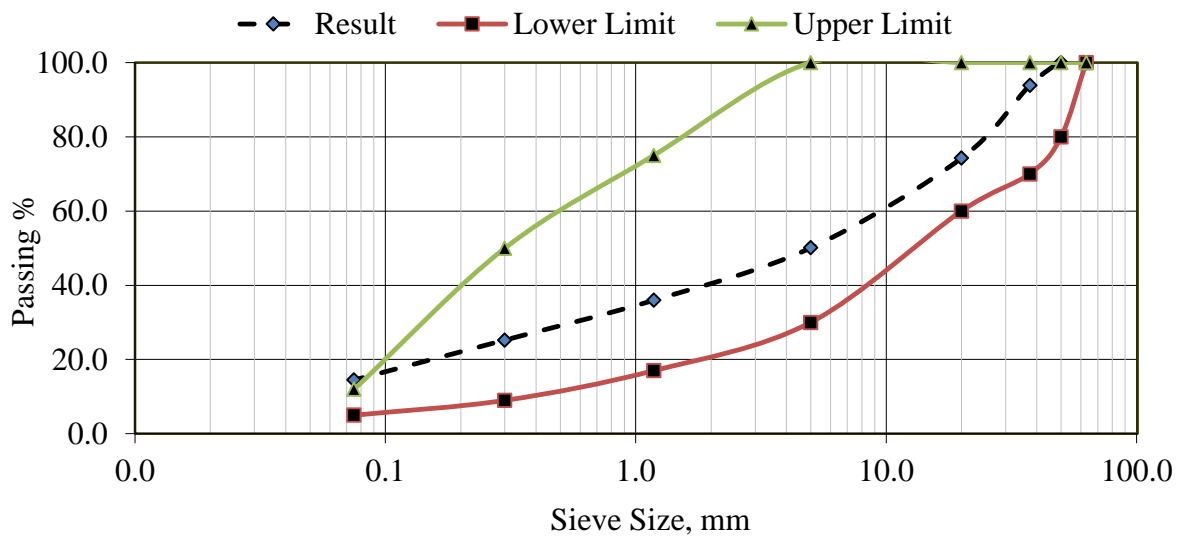
**Figure 8** Gradation of existing sub-base material from 18+300-18+400

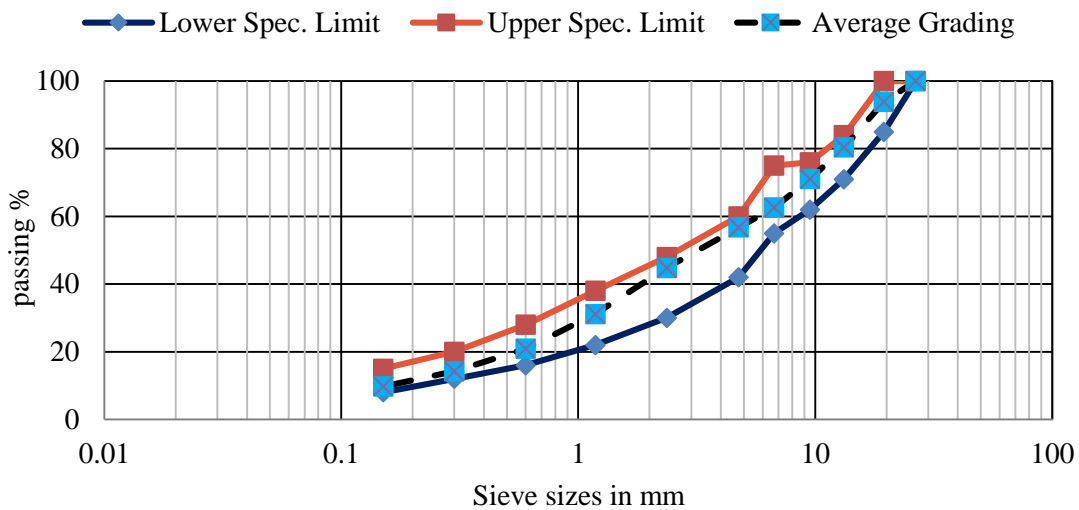
The asphalt concrete sample was taken from two places of poor sections of the road (18+300-18+400 and 9+200-9+300). The bitumen was obtained from the sampled asphalt concrete through the extraction process in the laboratory. The average bitumen contents at 9+200-9+300 and 18+300 -18+400 are 3.7% and 3.9%, respectively which are smaller than the required specification of 5%. The average bitumen content of 3.8% clearly shows the AC lacked some bitumen in the mix. Using too little bitumen in HMA causes Raveling and Weathering, Alligator cracking, Edge crack and Pothole. For this reason, alligator cracking, raveling, and a pothole formed on poor pavement condition (18+300-18+400) were due to low bitumen content. The average grading of the surfacing course is shown in Figure 9 and 10. Surface course material shall be dense, can be compacted, mechanically interlocking stability sufficiently to resist loads imposed during the design life of a pavement. A well-graded surface course exhibits all these behaviors. If the surface course material is not dense and not interlocked, the surface course is unable to resist traffic loading. This poor gradation of asphalt mix causes cracking, raveling, and rutting. Also occasionally potholes can occur. The grain size analysis of the existing asphalt concrete satisfied ERA standard specification which shows it is well graded. Therefore, gradation of the existing surface course material does not affect the occurrence of Rutting, alligator cracking, pothole and raveling observed on the poor condition pavement (18+300-18+400 station). In the same manner, the gradation of this material cannot be a cause of the formation of rutting on the poor condition of pavement (9+200-9+300 station).

**Figure 9** Gradation of existing surfacing course from 18+300-18+400

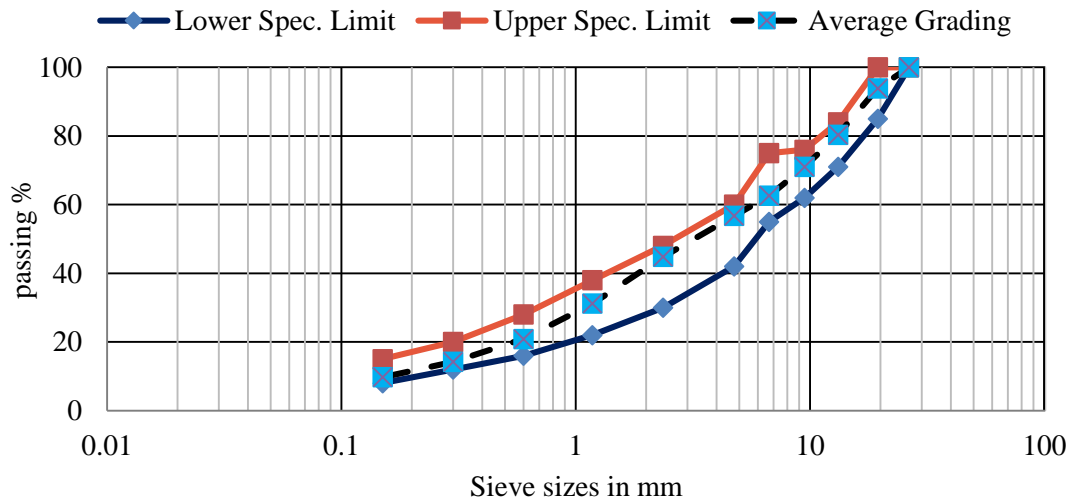
**Figure 10** Gradation of existing surfacing course from 9+200-9+30
