Field Study of Riparian Zone along Sarawak River at Bintawa, Kuching

Darrien Y.S. Mah and Allan P.P. Pui

Department of Civil Engineering, Faculty of Engineering, Universiti Malaysia Sarawak

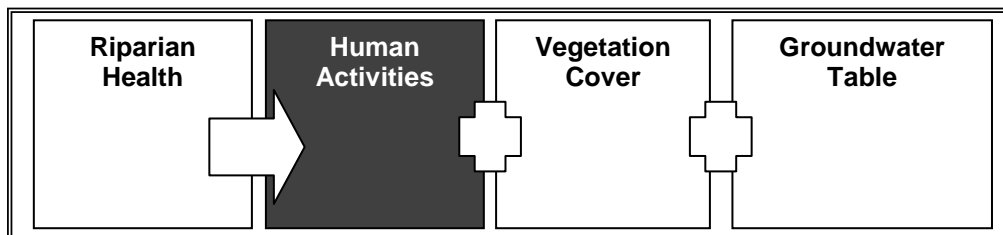
Figure 1: Framework to Assess Human Impacts on Riparian Health

This study has been carried out at Bintawa, located east of Kuching City. Bintawa is a light industrial estate sandwiched between the Sarawak River in the north and residential houses along its southern fringe. The main objective is to detect and assess changes of this stretch of riparian zone. The selected location is suitable for this study due to the presence of natural vegetation and human disturbances within the riparian zone. Three selected indicators—human activities, vegetation cover and groundwater table can be easily assessed. Hence, with the known conditions and functions of the existing riparian zone, these three indicators—vegetation cover, groundwater table and human activities within the system provide clues about the impacts of human disturbances on the riparian conditions. Figure 1 below shows how the assessment is done.

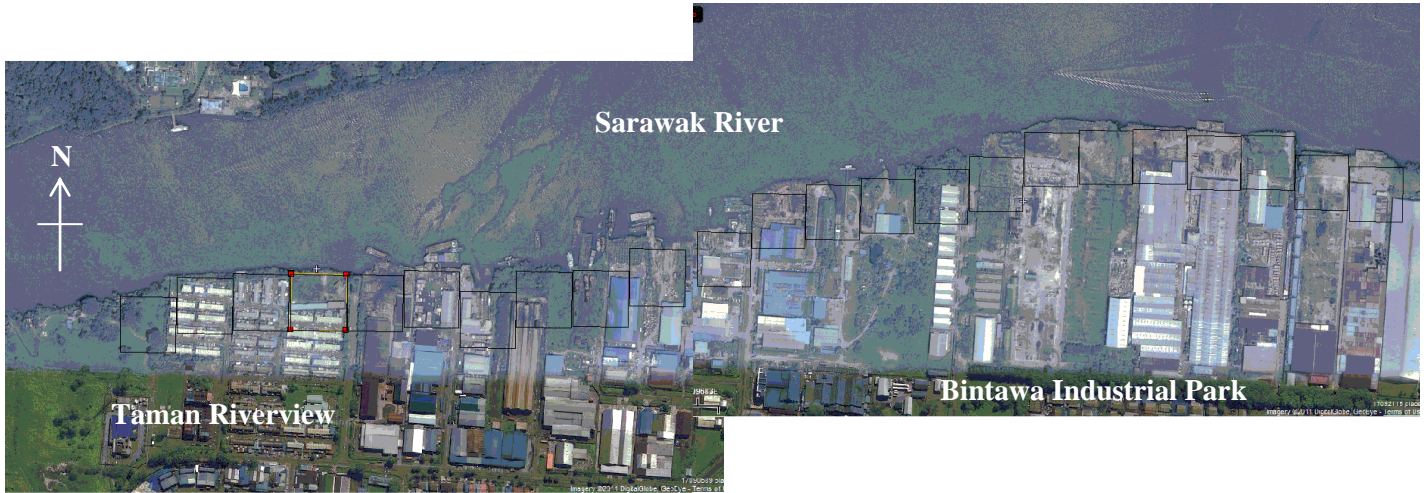
Figure 2: Study Area with Delineated Sampling Plots

For this study, 100 m x 100 m sampling plots are delineated to assess vegetation cover and human activities, a method common to biologists [5]. Although the range of riparian width varies, 100 m x 100 m plots are preferred rather than smaller plots as the former cover adequately the vegetation and human activities along the river edge. Twenty-three (23) plots are marked out along the riverbank, as shown in Figure 2. Assessment is basically carried out by analysing the spatial relationships between the earth's features and events [6]; this is done by utilising the Environmental System Research Institute (ESRI)'s ArcView GIS software. Based on the layout of vegetation cover and human activities within the sampling plots such as concrete drains, roads, parking lots and buildings, the GIS produces a mapping of distribution, abundance and interspersed of the two land uses [7].

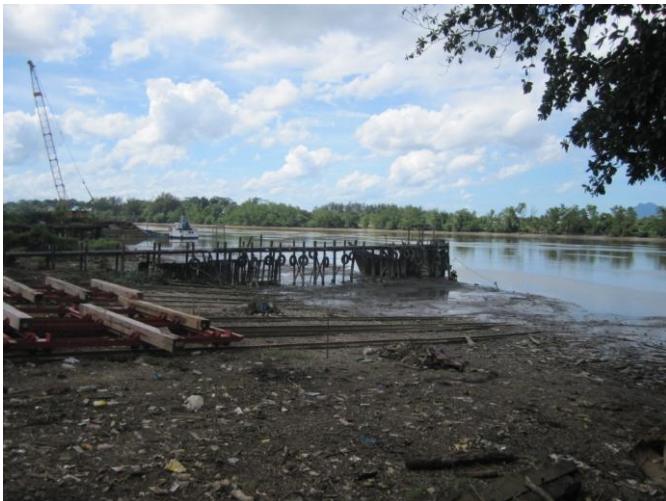
Figure 3: Jetties and Riverbank Conditions in Bintawa

Bintawa is a mixed-use area comprising factories, garages and residential houses. Most of the industrial establishments are constructed with riverside embankments and jetties along the riverbank of Sarawak River, as shown in Figure 3. These developments have negatively affected the natural riparian zone. The soil type of the riverbank is naturally peat soil. However, the construction of embankments with building materials such as concrete, stone, and timber has changed the soil characteristics.

The native vegetation consists of coconut palms, nipah palms, areca, and sago palms [8]. Most of the native vegetation has been destroyed by human activities. However, healthy small trees, shrubs and grasses are found along the riparian zone, as shown in Figure 4. These plants are periodically maintained by the City Council. The observed vegetation species are physiologically adapted to a greater amount of groundwater compared with the upland species [9],[10]. The well-being of the riparian zone is perceived to be relatively straightforward given the lushness of vegetation growth in the tropical environment, as demonstrated through the stark contrast between the bare grounds in Figure 3 and the greenery in Figure 4.

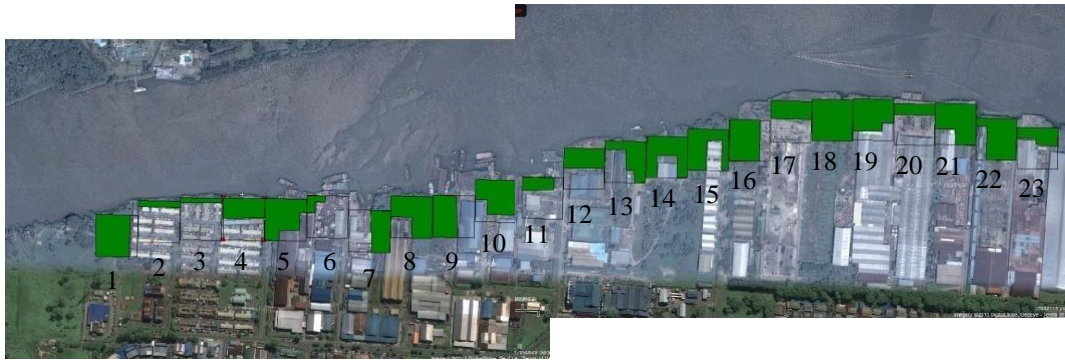
Figure 5: Coverage of Vegetation Cover

Vegetation is a reliable indicator of riparian health due to its relative permanence. Its lushness reflects the nature of underlying soils, local climate, current and past management; it is also the medium in which animals live and feed [14],[15]. The extent of vegetation cover is shown in Figure 5, which has been digitised through ESRI ArcView GIS. Numbering of the plots is shown in the same figure. A summary of their respective areas and percentages of coverage is listed in Table 2.

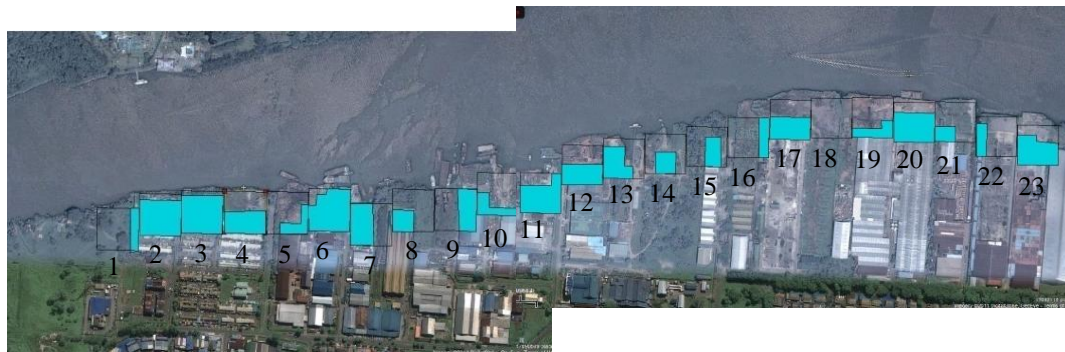
Figure 6: Coverage of Human Activities

Human activities influence the composition and integrity of riparian vegetation. The principal culprits are industrial and urban developments, with their attendant problems of pollution and disturbance. Human footprint on a riparian zone is measured to provide confirmation of its impacts and early warnings of the effects of excessive human or management pressure [14]. The coverage of human activities is shown in Figure 6. Plot 6 has the highest percentage of human activities, which is 91.82% of the total area, as shown in Table 3.

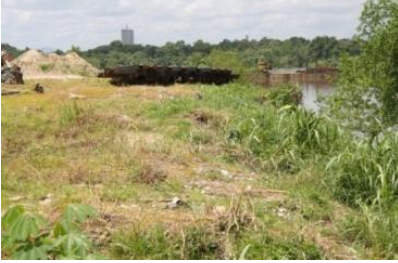
Plot	Groundwater Level	Remarks
1	Low	Soil filling and compaction of riparian zone

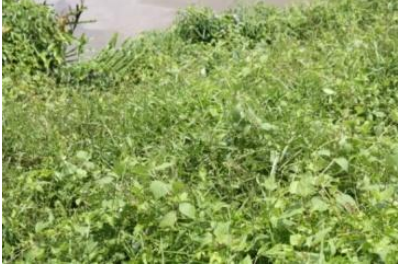
2	Low	Dry soil with weeds and grasses

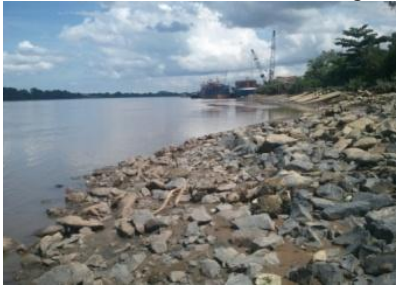
3	Low	Embankment with stones and bare ground

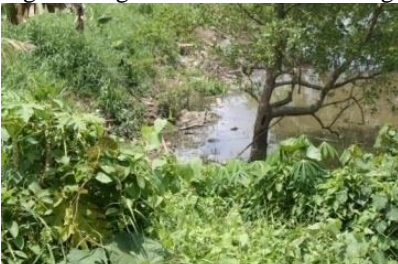
4 – 5	High	Vegetation growth near the water edge

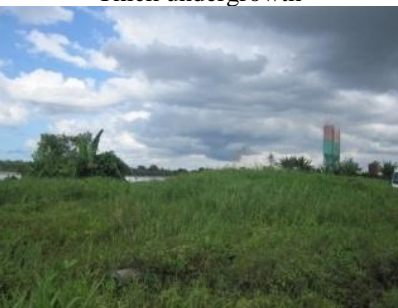
6 – 16 17 – 18 19 – 23	Medium High Medium	Thick undergrowth

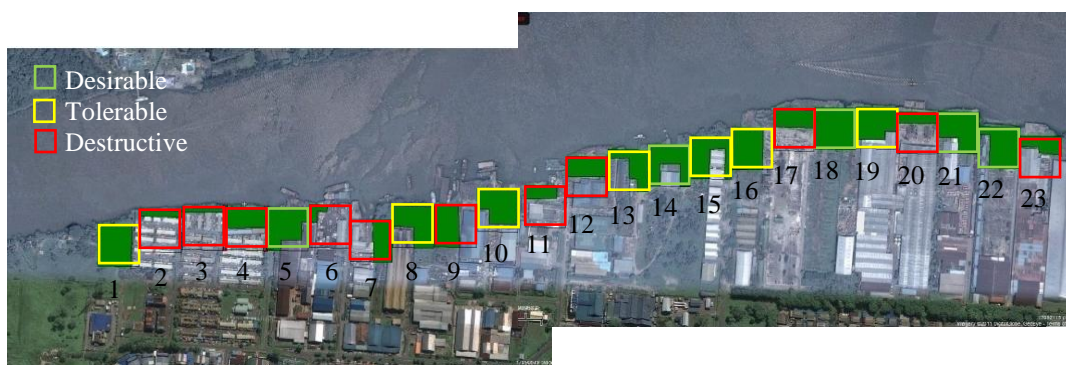
Figure 7: Distribution of Desirable, Tolerable and Destructive Plots

From the table above, the impacts of human activities on the riparian health can be divided into three categories. On the top (shaded with green), it is named “desirable range” of functioning riparian zone, with a mean of 12% human activities and the range is 0 to 17.9%. In the middle is the “intermediate functioning” riparian zone, which can be sub-divided into upper half and lower half. Practically, it can be said the upper half is approaching the functioning category, and thus it is named “tolerable range”, with a mean of 25% human activities. The lower half falls into the bottom category (shaded in orange) indicating “destructive range”, with a mean of 67% human activities. Distribution of the three categories is shown in Figure 7.

Based on the figure above, it is evident that a high percentage of vegetation cover indicates proper functioning of the related riparian zone. Presence of vegetation is one of the main characteristics of intact river corridors. The existence of continuous vegetated strips along the riverbank is an evidence of the continuous flow or movement of groundwater. The desirable and tolerable ranges have high and medium groundwater tables respectively, with the exception of Plot 1.
