Journal of Civil Engineering, Science and Technology

INVESTIGATING CAUSES OF FLEXIBLE PAVEMENT FAILURE: A CASE STUDY OF THE BAKO TO NEKEMTE ROAD, OROMIA, ETHIOPIA

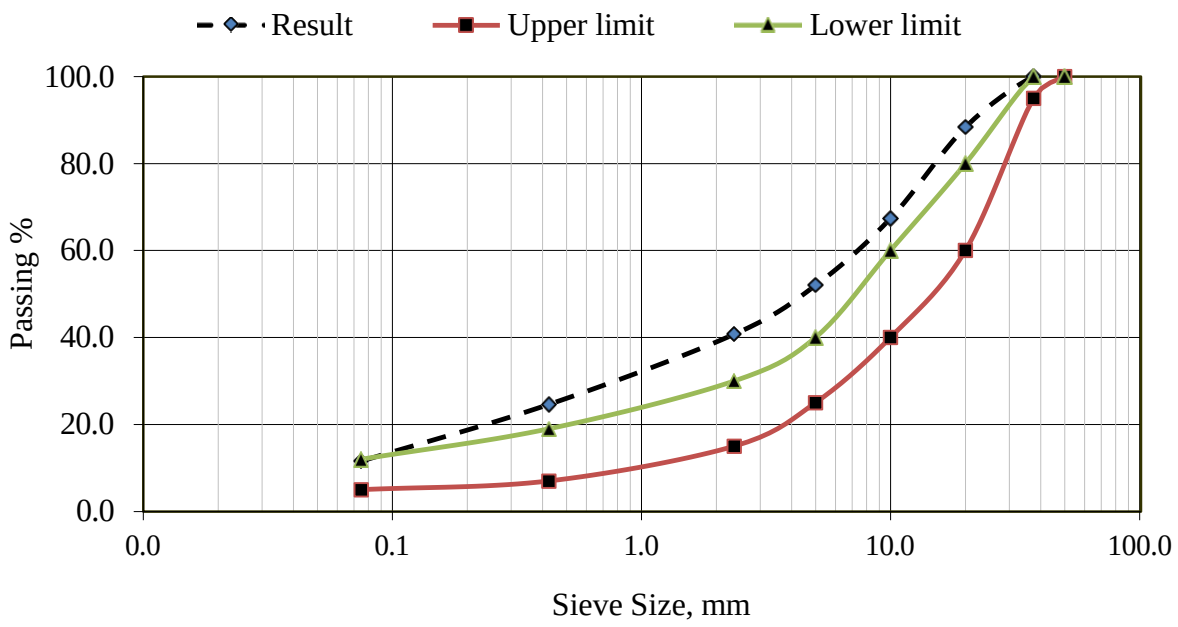
Figure 5 Gradation of existing base course material from 38+900-39+000

This test was performed to determine the percentage of different grain sizes contained within the Base course materials. Figure 5 and 6 show the sieve analysis test results of Base Course Materials. From 38+900-39+000 stations (failed pavement), the gradation results are completely out of the ERA specification range. This indicates that the base course at this station was poorly graded. Also, from 18+300-18+400 station (poor pavement condition), the gradation results are partially in the range of ERA specification. This implies that the base course at this station was poorly graded. Similarly, from 9+200-9+300 station (poor pavement condition) the gradation results of base course material are fully into the range of ERA specification and consequently, the materials were well graded. The base course material shall be of such nature that can be compacted readily to form a firm, stable base layer. And also a placed layer must have a mass mechanical interlocking stability sufficient to resist loads imposed during the design life of a pavement. Well-graded base course materials are dense and more compact than poorly graded. As a result; they are more resistant to rutting, alligator cracking, and pothole. Therefore, from 38+900-39+000 station (failed pavement), poorly graded base course can be a cause for the occurrence of Pothole and raveling. Similarly, rutting, pothole, and alligator cracking observed from 18+300-18+400 station (poor pavement condition) was also due to base course gradation.

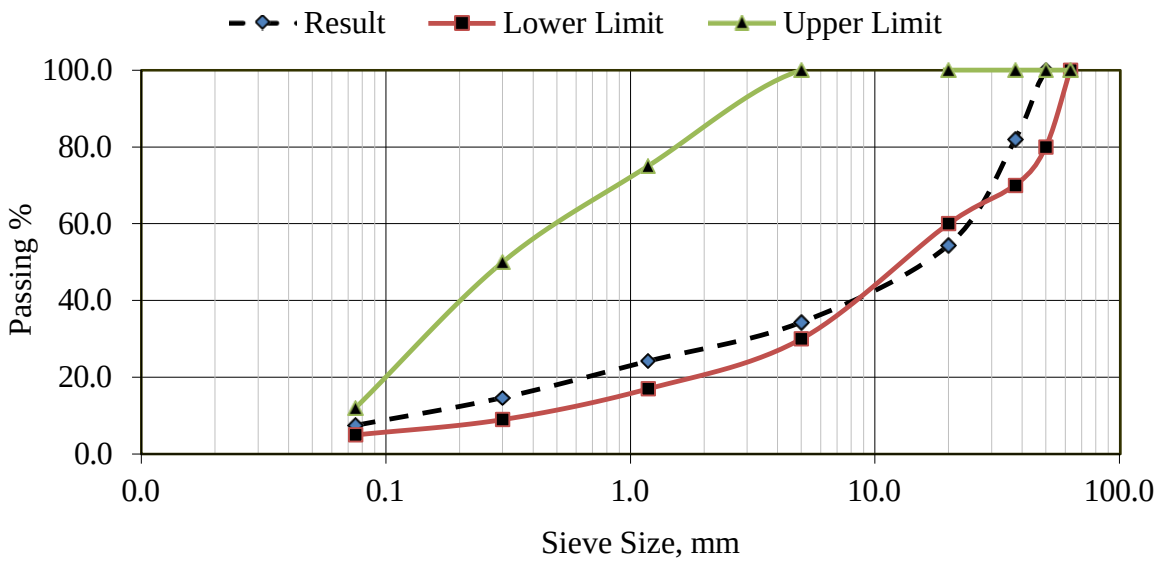
Figure 7 Gradation of existing sub-base material from 9+200-9+300

In the whole stretch of the road, the brown granular material was used as a sub-base material. For all samples tested gradation results are within the minimum and maximum range limit of the ERA specification except sample at station (9+200-9+300). The gradation result of sub-base material from the 9+200-9+300 station indicated that the pavement is poor which may be due to the material was not dense and durable. For this reason, they were not able to resist traffic loads and rutting occurred. Therefore, poorly graded sub-base materials can be responsible for the manifestation of rutting on the road sections. Figure 7 and 8 show the grain size analysis result and comparison of sample sub-base material gradation with the ERA manual specification.

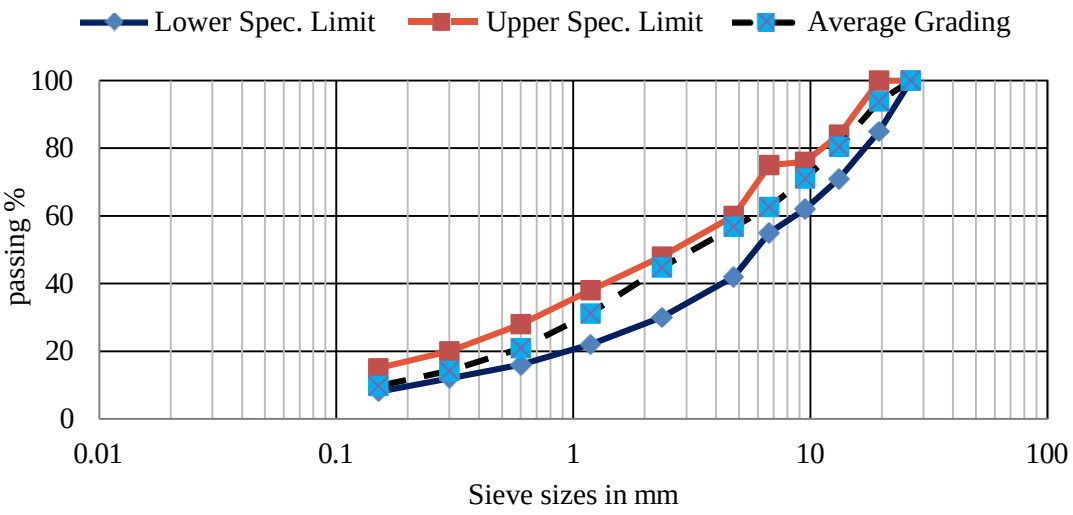
Figure 9 Gradation of existing surfacing course from 18+300-18+400

The asphalt concrete sample was taken from two places of poor sections of the road (18+300-18+400 and 9+200-9+300). The bitumen was obtained from the sampled asphalt concrete through the extraction process in the laboratory. The average bitumen contents at 9+200-9+300 and 18+300 -18+400 are 3.7% and 3.9%, respectively which are smaller than the required specification of 5%. The average bitumen content of 3.8% clearly shows the AC lacked some bitumen in the mix. Using too little bitumen in HMA causes Raveling and Weathering, Alligator cracking, Edge crack and Pothole. For this reason, alligator cracking, raveling, and a pothole formed on poor pavement condition (18+300-18+400) were due to low bitumen content. The average grading of the surfacing course is shown in Figure 9 and 10. Surface course material shall be dense, can be compacted, mechanically interlocking stability sufficiently to resist loads imposed during the design life of a pavement. A well-graded surface course exhibits all these behaviors. If the surface course material is not dense and not interlocked, the surface course is unable to resist traffic loading. This poor gradation of asphalt mix causes cracking, raveling, and rutting. Also occasionally potholes can occur. The grain size analysis of the existing asphalt concrete satisfied ERA standard specification which shows it is well graded. Therefore, gradation of the existing surface course material does not affect the occurrence of Rutting, alligator cracking, pothole and raveling observed on the poor condition pavement (18+300-18+400 station). In the same manner, the gradation of this material cannot be a cause of the formation of rutting on the poor condition of pavement (9+200-9+300 station).
