Journal of Civil Engineering, Science and Technology
Volume 16, Issue 2, September 2025, 210-228

ANALYSIS OF PAVEMENT DRAINAGE SYSTEM: A CASE STUDY ALONG BURE TO INJIBARA TOWN ROAD SECTION IN AMAHRA REGION

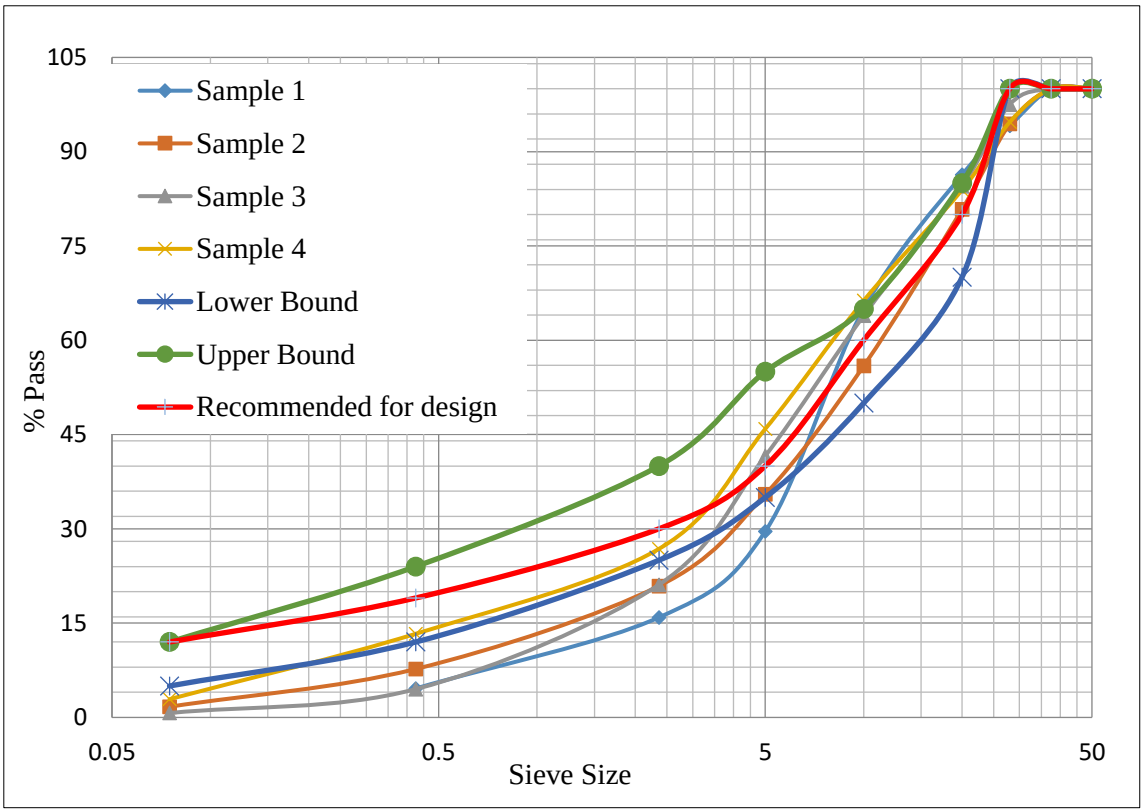
Figure 3 Sieve analysis test result for base course material

All base course materials must have a suitable particle size distribution to provide excellent mechanical stability. They must also contain enough fines (material passing the 0.425 mm sieve) to compact densely. In the study region, sieve analysis test results were found to be within the upper and lower bound specifications.

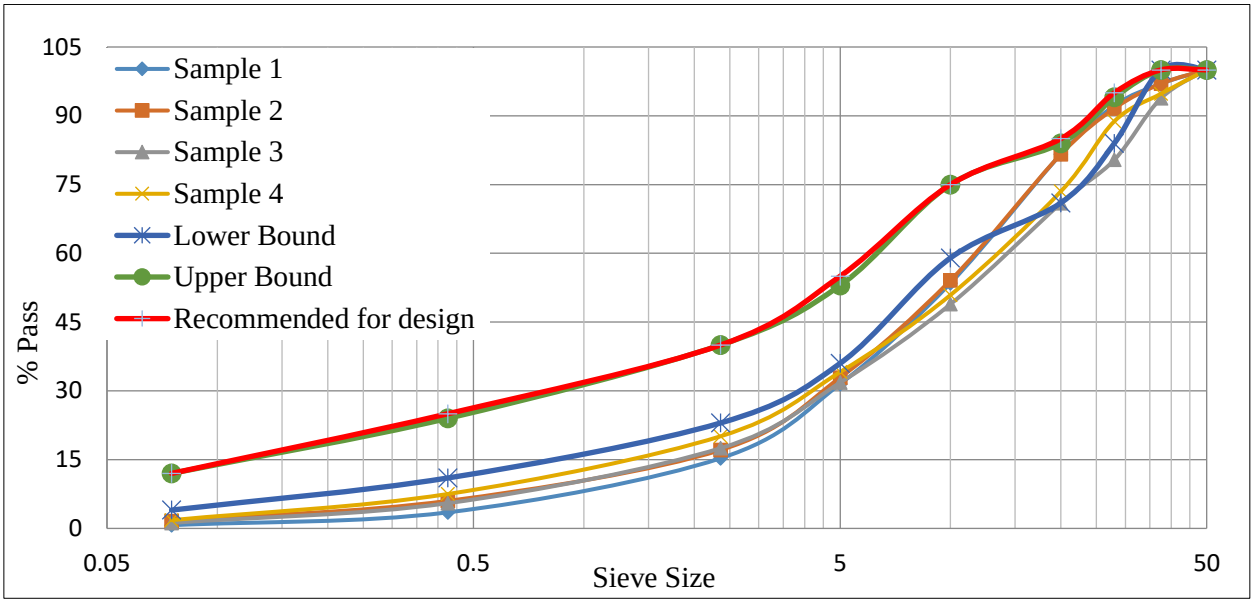
Figure 4 Sieve analysis test result for subbase material

The subbase material is a critical component of the pavement structure, as it distributes loads and serves as a working platform for the construction of the upper pavement layers. In this instance, the quality of the subbase material was affected by moisture content and traffic loading, which caused excessive deformation. The sieve analysis test results for subbase material taken from the study area were found to be below the lower bound specifications.

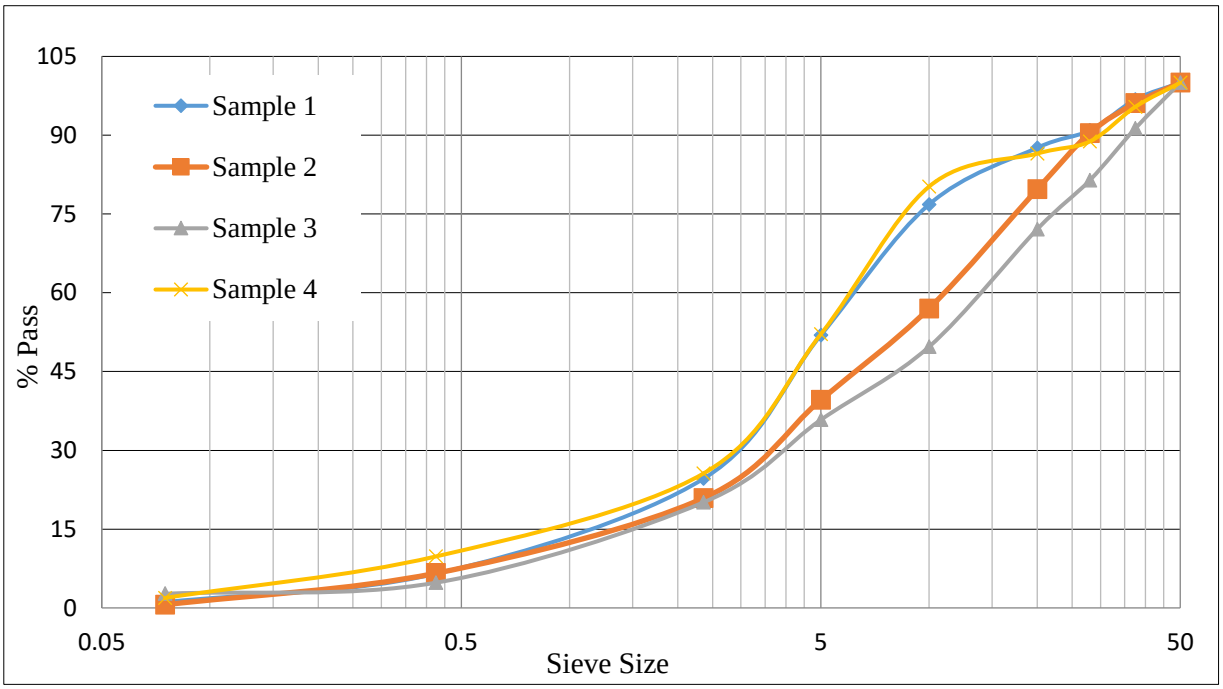
Figure 5 Sieve analysis test result for subgrade materials

When tire loads are applied to a subgrade that is too weak, the pavement will bend excessively and ultimately fail. This means that the materials will not interlock and bond properly to create a stable layer. Additionally, seepage increases moisture levels in pavement structures and embankments.

Many pavement damages and surface deterioration can be traced back to inadequate subgrade drainage, particularly over clay subgrade or shallow rock formations. Utilizing an open-graded subbase, along with draining fabric that directs water to roadside ditches, can significantly reduce the negative impact of stagnant water beneath the pavement [11].
