Volume 16, Issue 2, September 2025, 210-228

ANALYSIS OF PAVEMENT DRAINAGE SYSTEM: A CASE STUDY ALONG BURE TO INJIBARA TOWN ROAD SECTION IN AMAHRA REGION

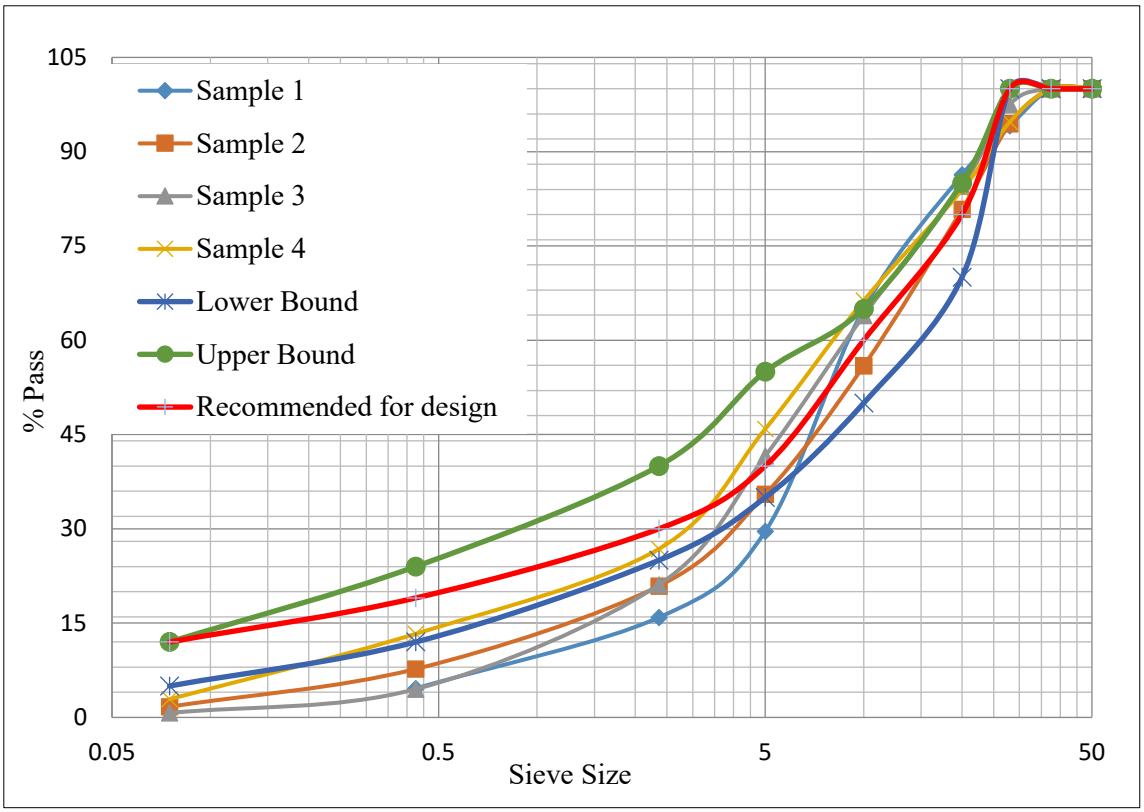
All base course materials must have a suitable particle size distribution to provide excellent mechanical stability. They must also contain enough fines (material passing the 0.425 mm sieve) to compact densely. In the study region, sieve analysis test results were found to be within the upper and lower bound specifications.

Figure 3 Sieve analysis test result for base course material

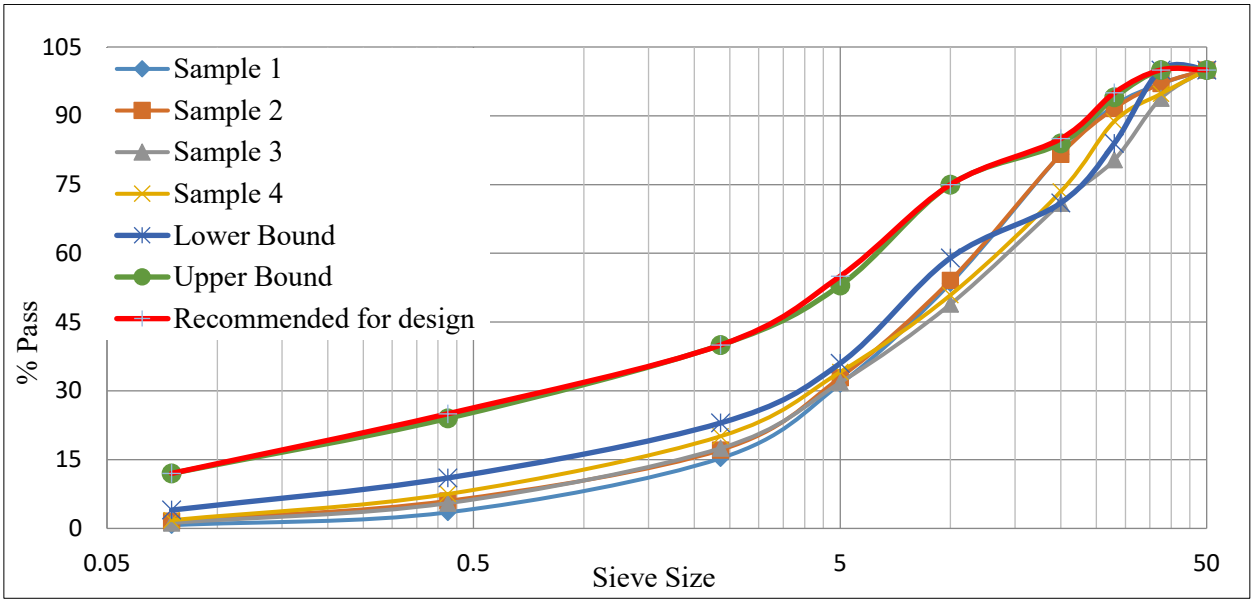
The subbase material is a critical component of the pavement structure, as it distributes loads and serves as a working platform for the construction of the upper pavement layers. In this instance, the quality of the subbase material was affected by moisture content and traffic loading, which caused excessive deformation. The sieve analysis test results for subbase material taken from the study area were found to be below the lower bound specifications.

Figure 4 Sieve analysis test result for subbase material

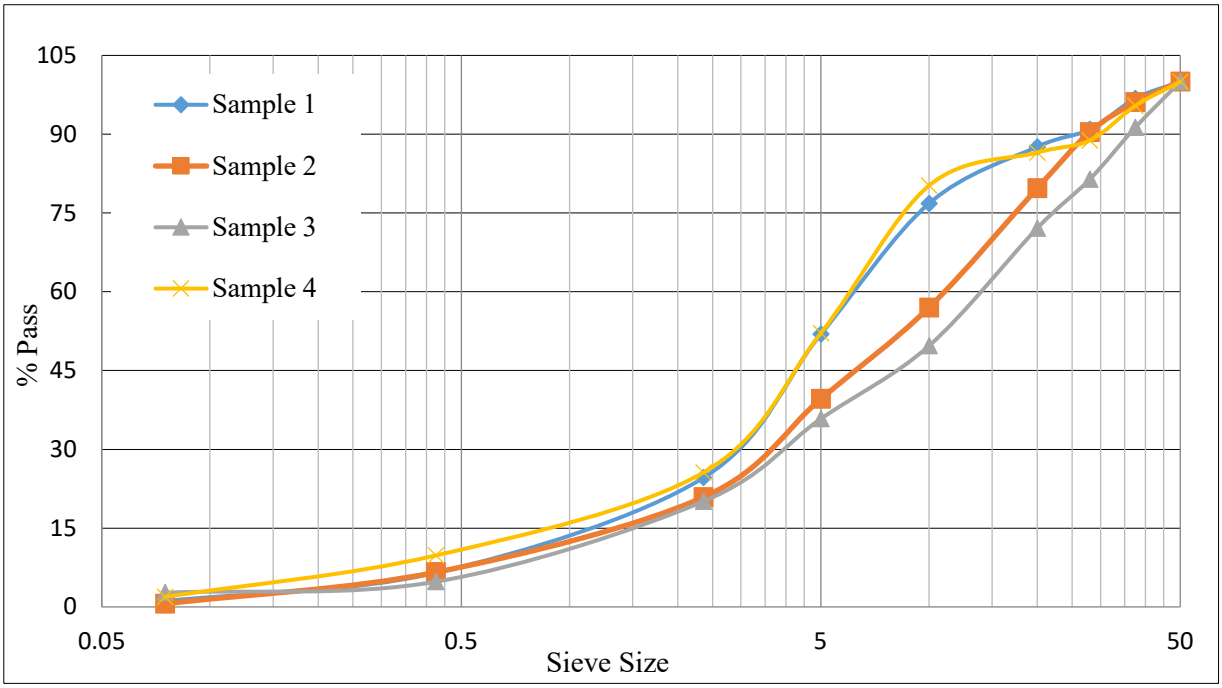
When tire loads are applied to a subgrade that is too weak, the pavement will bend excessively and ultimately fail. This means that the materials will not interlock and bond properly to create a stable layer. Additionally, seepage increases moisture levels in pavement structures and embankments.

Figure 5 Sieve analysis test result for subgrade materials
